Impact Of Blade Orientation And Cautery Mode When Delivering Electrocautery To Transvenous Leads Using An Insulated Blade Jeremiah Wasserlauf¹, MD, MS, Taiki Esheim², MBA, Natasha M. Jarett², BS, Eric K.Y. Chan², PhD, FHRS and Bradley P. Knight¹, MD, FHRS

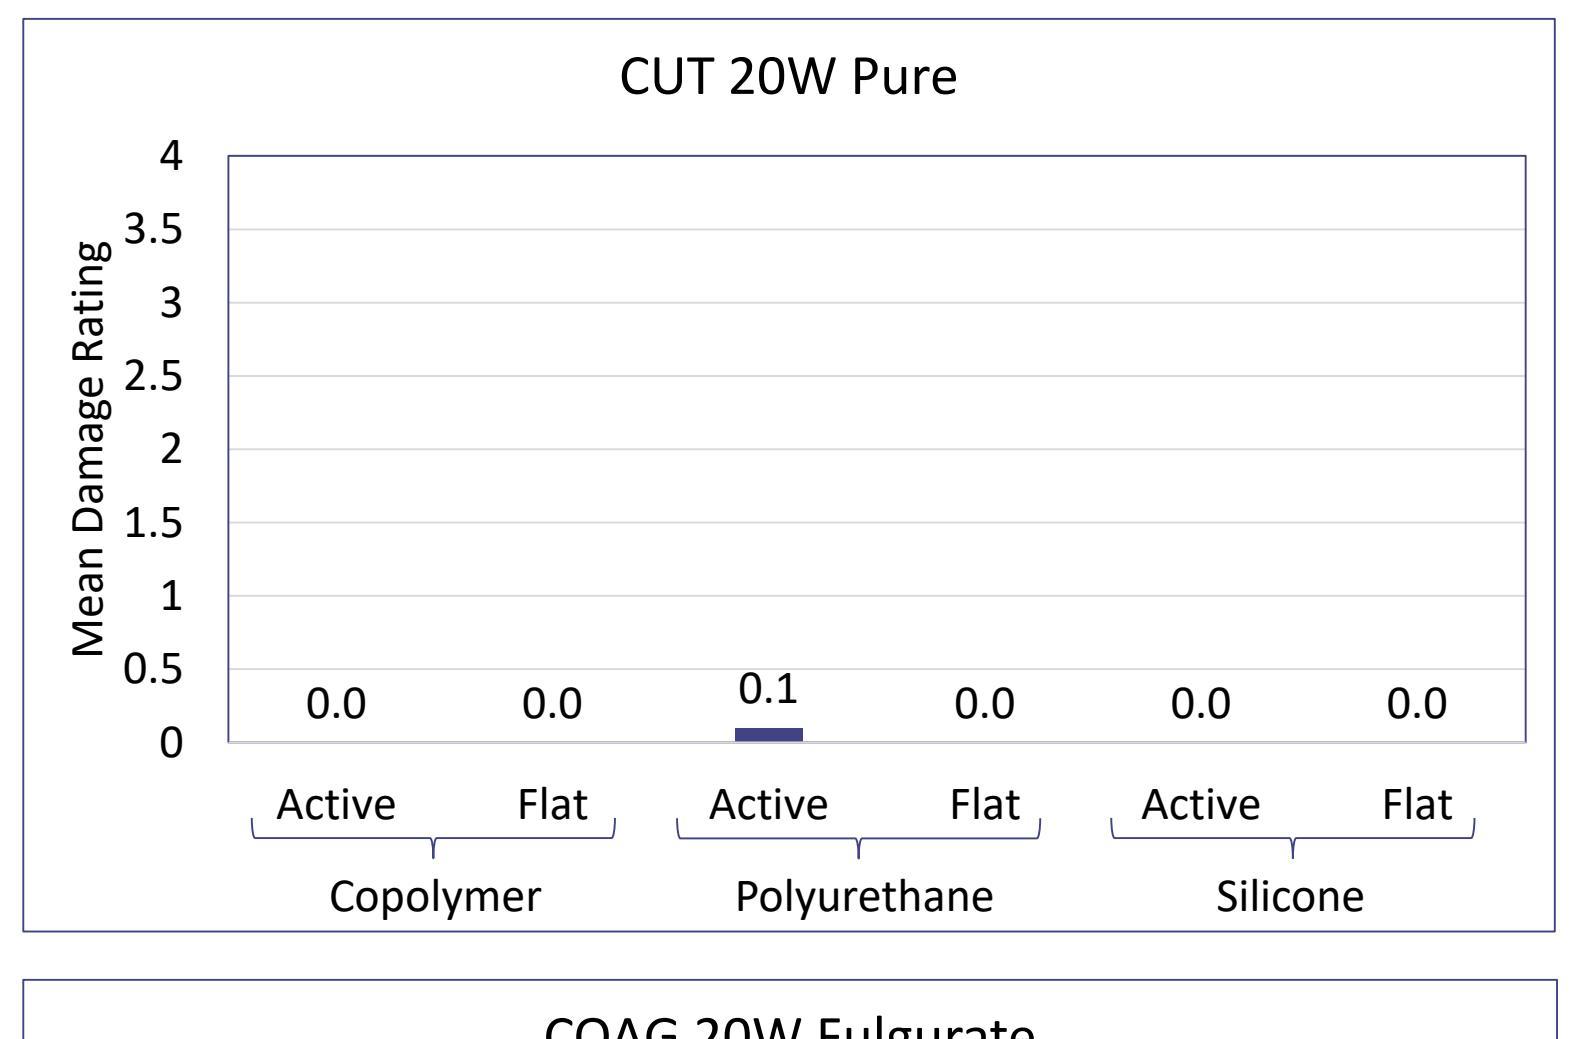
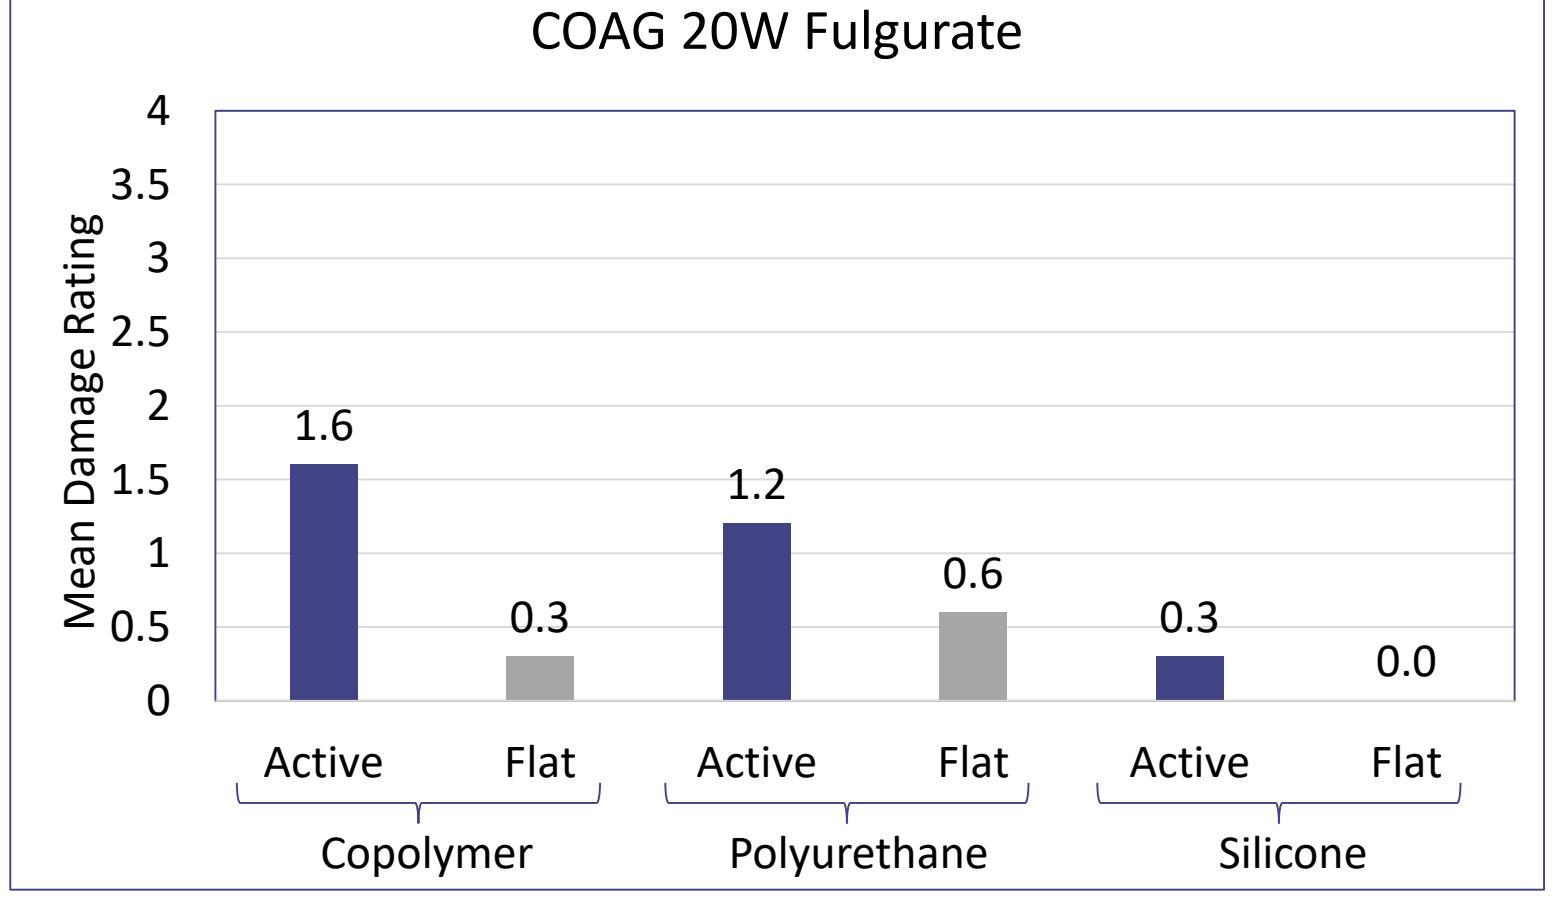
Figure 1: Mean Damage Ratings

- More lead samples were damaged using COAG vs. CUT (48% vs 2%, p<0.0001). The mean damage rating was 0.67 for COAG and 0.02 for the CUT setting.
- > When stratified by orientation, 74% of lesions using COAG and active orientation had damage, compared with 22% of lesions with COAG and flat orientation (p=0.0002).
- > When COAG lesions were stratified by lead insulation material, both the copolymer (61%) and polyurethane (68%) lead insulations had significantly greater damage than the silicone (17%) lead insulation (p=0.006 and p=0.003, respectively).
- > Using CUT, no significant difference was seen by insulation type or orientation since only a single CUT lesion was associated with
- damage.
- \blacktriangleright Mean applied force was 0.14 ± 0.11 N.
